Manhole Inspection Summary

Manhole # S17Q__015MH

Insp Date: **5/28/09 11:20 AM**

Location Address: **947 BRUNSWICK ST**

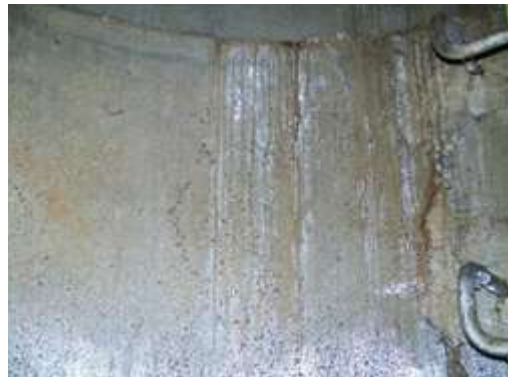
Defect 1

Infiltration: ☐ None ☒ **Joint** ☐ Cracks ☐ Mortar ☐ Roots ☒ **Wall**

INFILTRATION AT BARREL JOINT

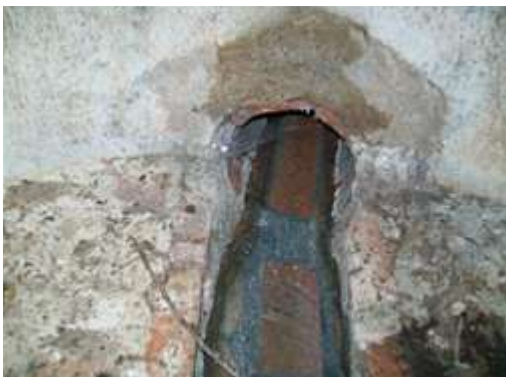
Defect 2

BARREL WALL INFILTRATION

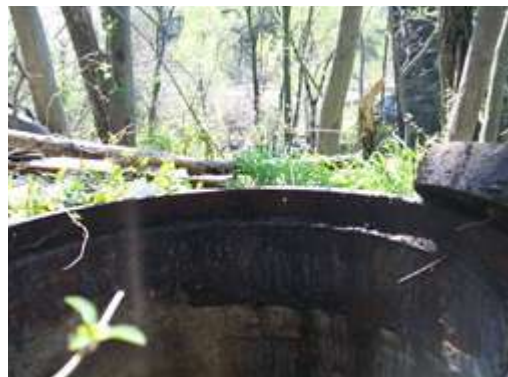
Defect 3

Frame Offset: **0** (in.) Condition: ☐ Sound ☐ Cracked ☒ **Leaks**

FRAME INFILTRATION

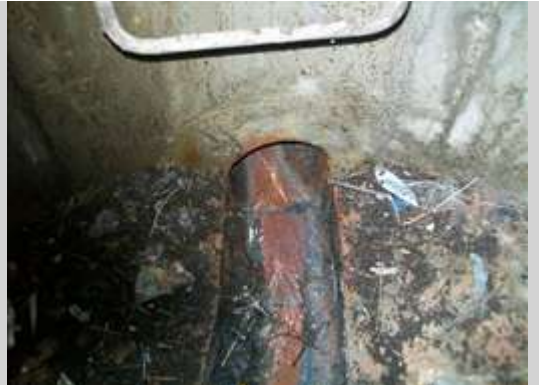
12 O'Clock Outflow

8 in. Circular Gravity Sewer
Pipe Out @ 12 O'Clock

Pipe Height: **8.4** (in.) Rod and Bar (Angled)
Pipe Material: **Clay** ☐ Pipe Lined
Invert Depth: **18.20** (ft.) Flow Characteristics: **Slow**
Deposits: ☒ None ☐ Mud ☐ Sludge ☐ Debris ☐ Grease
Silt Depth: **0** (in.) Deposits Extent:
Infiltration: **None** Pipe Seal Cond: **Sound**

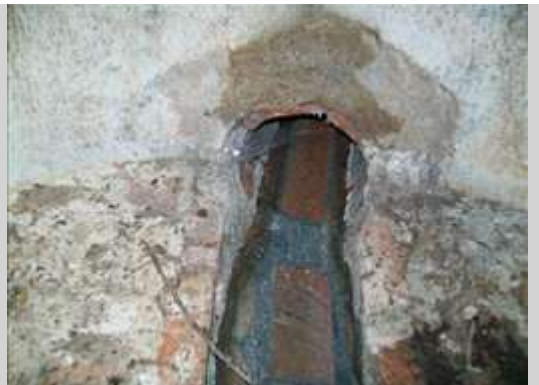
8 O'Clock Inflow

8 in. Circular Gravity Sewer
Pipe In @ 8 O'Clock

Pipe Height: **8.4** (in.) Rod and Bar (Angled)
Pipe Material: **Clay** ☐ Pipe Lined
Invert Depth: **18.00** (ft.) Flow Characteristics: **Slow**
Deposits: ☒ None ☐ Mud ☐ Sludge ☐ Debris ☐ Grease
Silt Depth: **0** (in.) Deposits Extent:
Infiltration: **Evidence** Pipe Seal Cond: **Sound**
